## CANAL REHABILITATION IN THE SPOTLIGHT

Following a request from an Mpumalanga irrigation board, SABI organised a discussion forum on the rehabilitation of canals to take place directly after the SAAFWUA meeting on 8 June 2010 in Groblersdal.

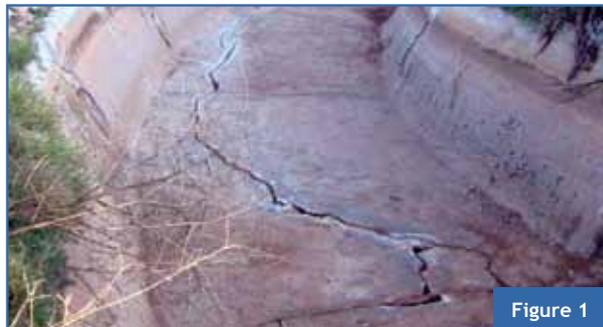
Figure 1

He emphasized that the function and profile of the canal must be taken into consideration together with the state of deterioration and funds available in the approach to find a canal-specific rehabilitation solution for your specific canal. (Figure 1)

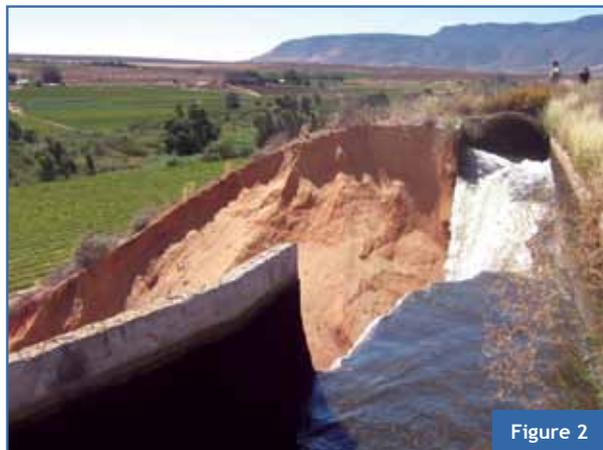
Figure 2

According to DWA canals have a life expectancy of 40 years, which has obviously been exceeded long ago. The LORWUA took over the canals from DWA in 2001, and the poor condition of the canals is limiting the supply of water to the scheme. Annual maintenance of R4m is budgeted for, and R1m has been spent on experimental sections. In 2010, approximately R11m is to be spent on plastering. The water users understand the importance of rehabilitation, especially as a recent canal failure damaged vineyards, interrupted water supply and were expensive to repair (Figure 2 and 3).

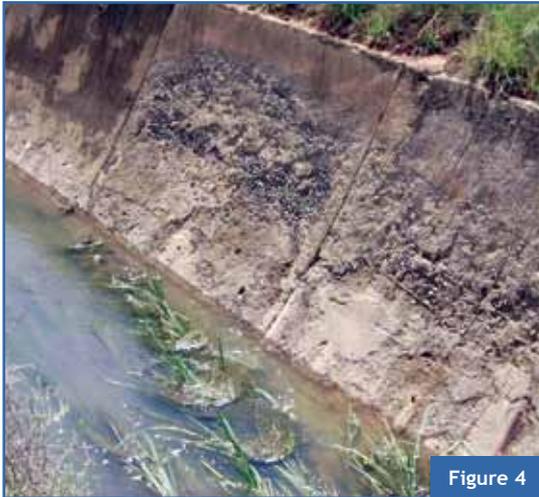
Figure 4

He emphasized the importance of maintenance as surface roughness increase due to the presence of algae and water-grass, exposure of coarse aggregate in concrete and sediment collecting on canal bed, which all contributes to reduced canal capacity. Bridge pillars also collect debris to clog up the flow area (Figures 4 & 5).
